VEHICULAR IMPACT TESTS OF A
TRUCK MOUNTED ATTENUATOR
CONTAINING VERMICULITE
CONCRETE CELLS

1. REPORT NO. FHWA/CA/TL-80/26		2. GOVERNMENT ACCESSION NO.		3. RECIPIENT'S CATALOG NO.	
4. TITLE AND SUBTITLE VEHICULAR IMPACT TESTS OF A TRUCK MOUNTED ATTENUATOR CONTAINING VERMICULITE CONCRETE CELLS				5. REPORT DATE June 1980

16. ABSTRACT Six vehicular impact tests were conducted. Cars ranging in weight from 1890 lbs to 4480 lbs impacted the rear end of dump trucks at speeds of 45 mph. In five of the tests truck mounted attenuators (TMA's) were used on the trucks. The TMA tested was a 6 ft-0 in. long by 8 ft-0 in. wide by 2 ft-0 in. high plywood box enclosing 84 crushable vermiculite concrete cells arranged in a designed pattern. The tests were intended to study 1) the effectiveness of the TMA in reducing car and truck damage and decelerations, 2) the vehicle trajectories after impact and specifically the roll ahead distance of the trucks using different truck braking conditions, and 3) other characteristics of the TMA's such as ease of use, amount of debris after impacts, durability, etc. It was concluded that the TMA was quite helpful in reducing vehicle damage and decelerations for l

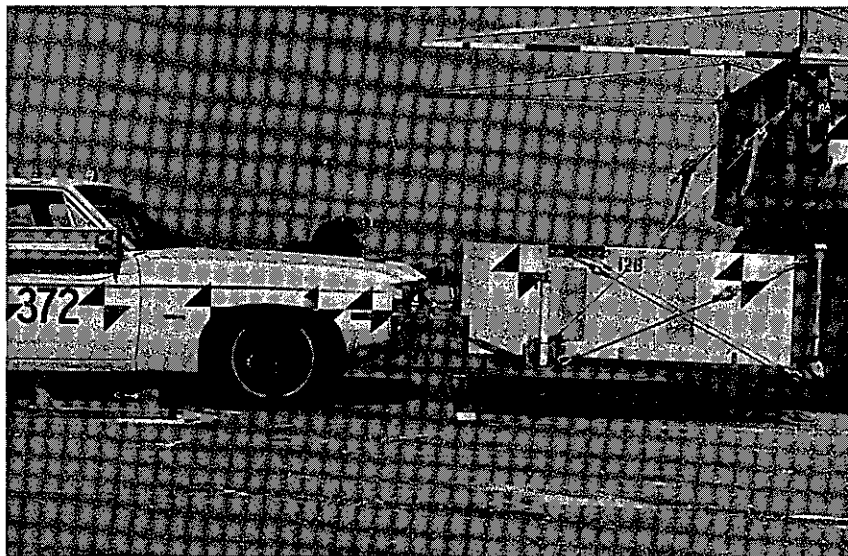
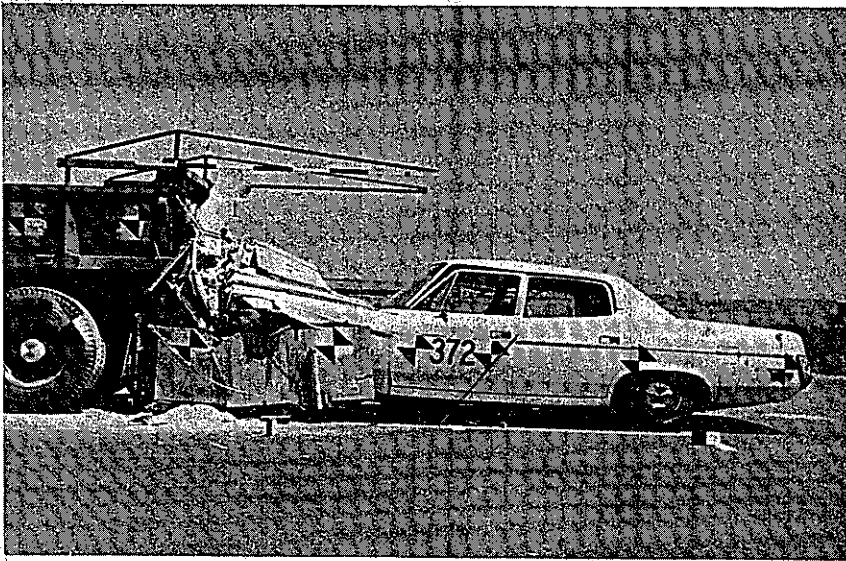
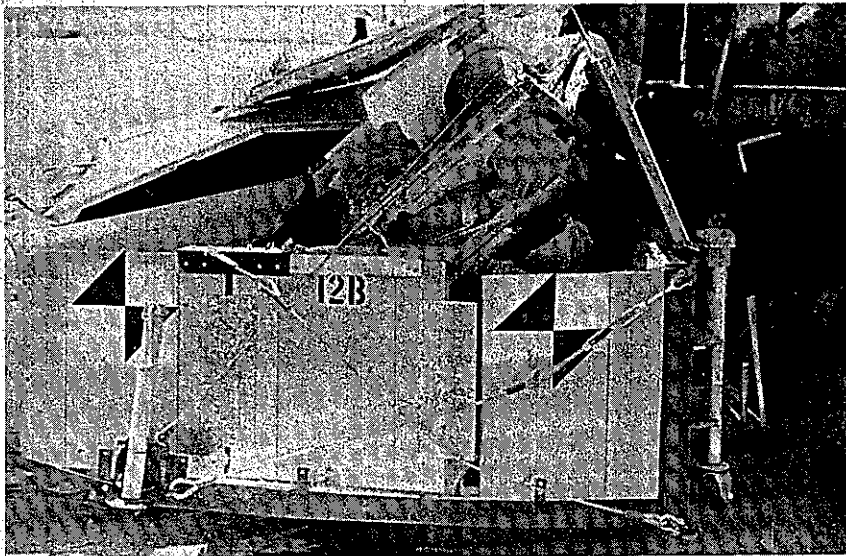
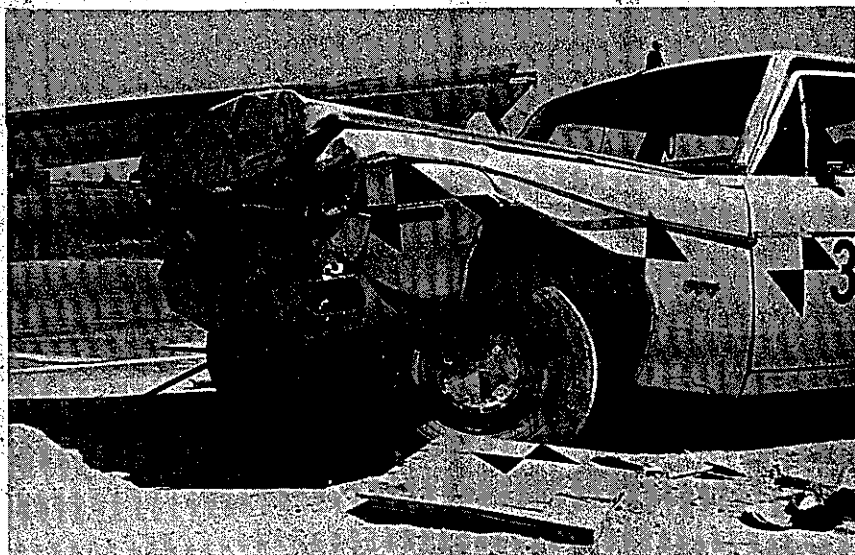
Figure 11.

Damage to the car was severe but less than in Test 371. The front end was uniformly crushed back, a maximum of 16 inches at a height of 24 inches above ground. The hood was crushed back a maximum distance of 15 inches at a height of 44 inches above ground.

The radiator was crushed back to the fan, the engine did not move, the windshield was cracked, all four doors were jammed, the left and right doorposts were deformed, the roof over the door posts was crimped, and the right front tire was flat. The car could not have been driven or

Truck damage was very light. One brake actuator was broken by the attenuator support.

The steel support frame under the TMA box was not reusable but the steel plate backup structure was salvaged. The TMA supports and controls mounted on the back of the truck incurred light damage. The upper control lever for the pintle hooks was bent. The upper truck mounting for the attenuator yielded which caused the backup structure on the TMA to move downward. This mounting was strengthened with a steel brace for Test 373.

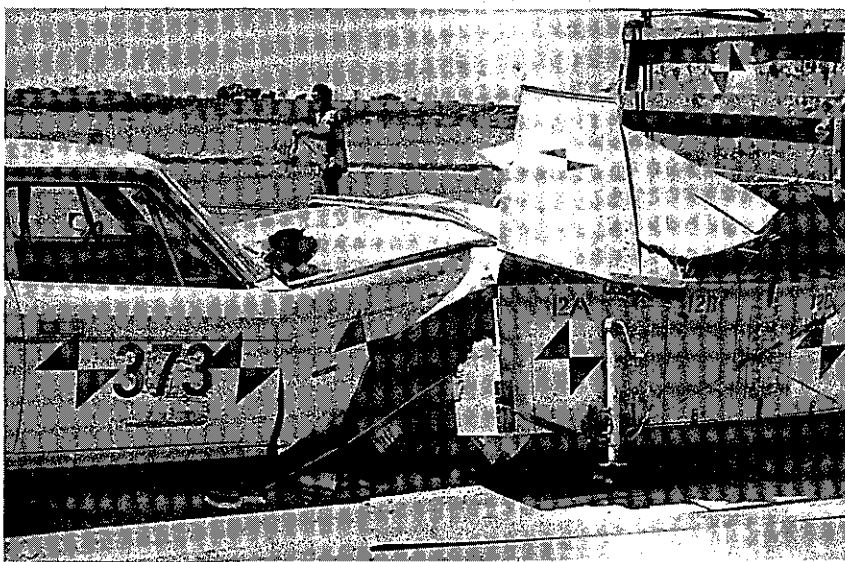
Test 373

Damage to the car was severe but less than in Test 372 and much less than in Test 371. The front end was uniformly crushed back a maximum of 9 inches at a height of 24 inches above ground. The hood was crushed back a maximum distance of 11 inches at a height of 44 inches above ground.

not move back, the windshield was cracked, all four doors were jammed, and the roof over the door posts on the left side was crimped slightly. The tires were all intact. The car could not be driven but it did roll because the front wheels were not disabled. There was no intrusion of vehicle parts or barrier components into the passenger compartment.

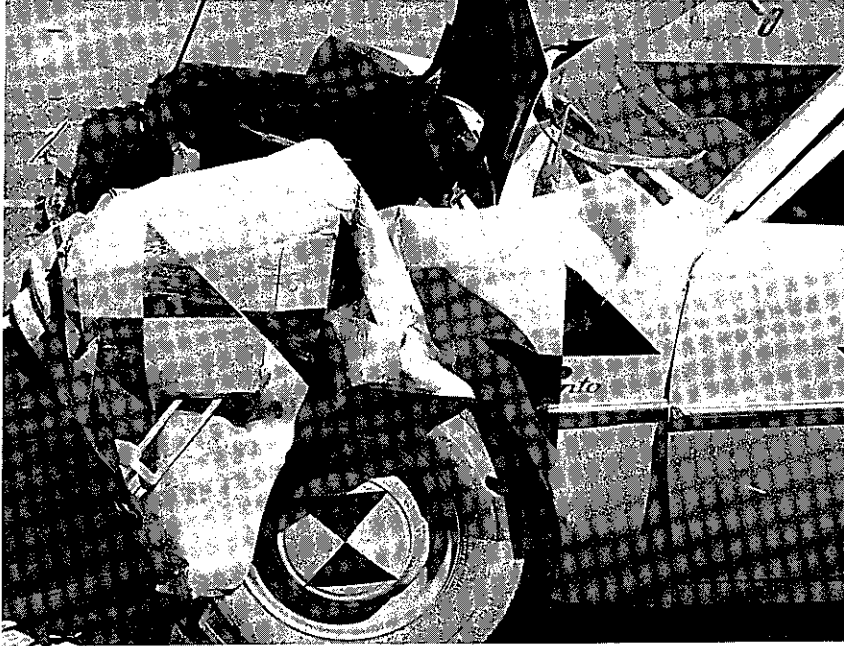
Test Car Damage

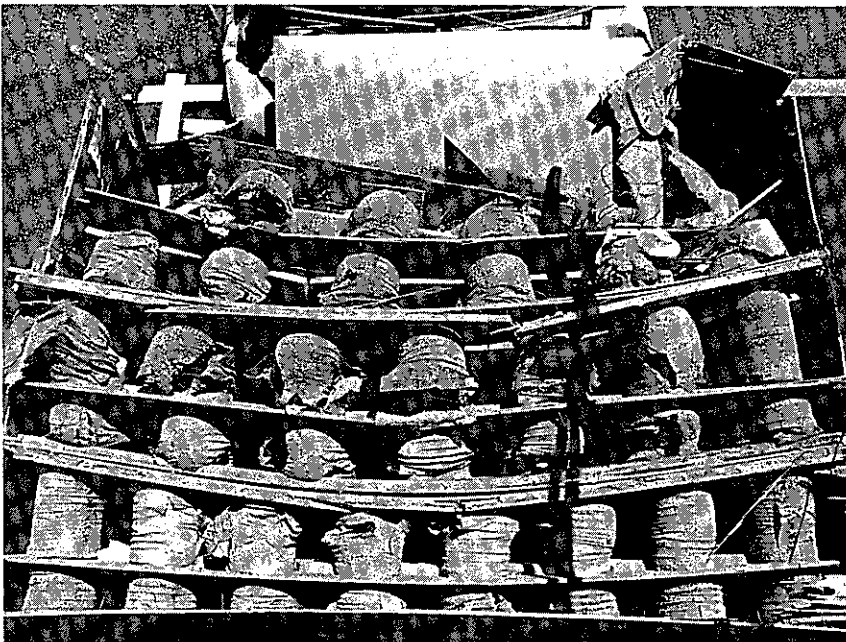
Plan View of TMA With
Plywood Cover Removed
Showing Crushed Vermic
ulite Concrete Cells

appeared that the car wheels were too small to climb up over this framework so the car could continue crushing the back rows of cells in the TMA.

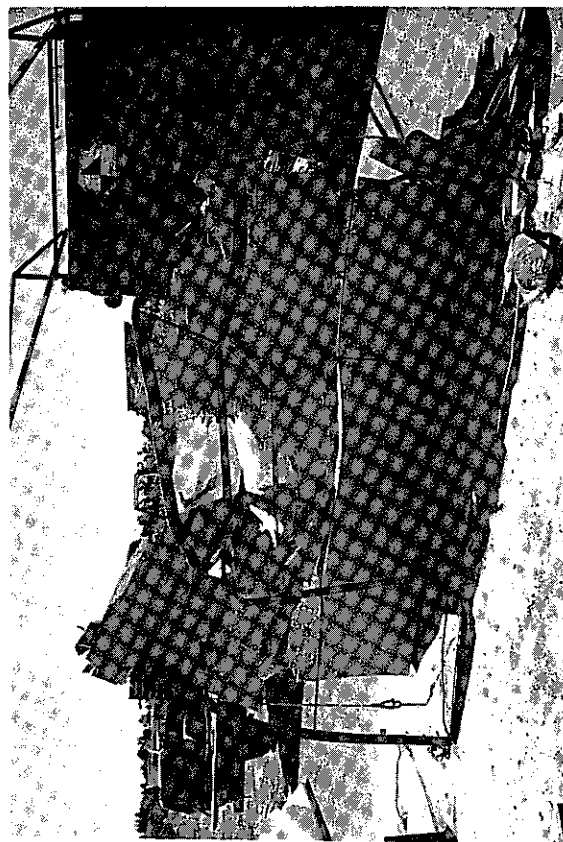
Figure 19. Test EAS-1. Test vehicles and TMA after impact. Bottom photos show top and bottom of TMA which was placed on end.

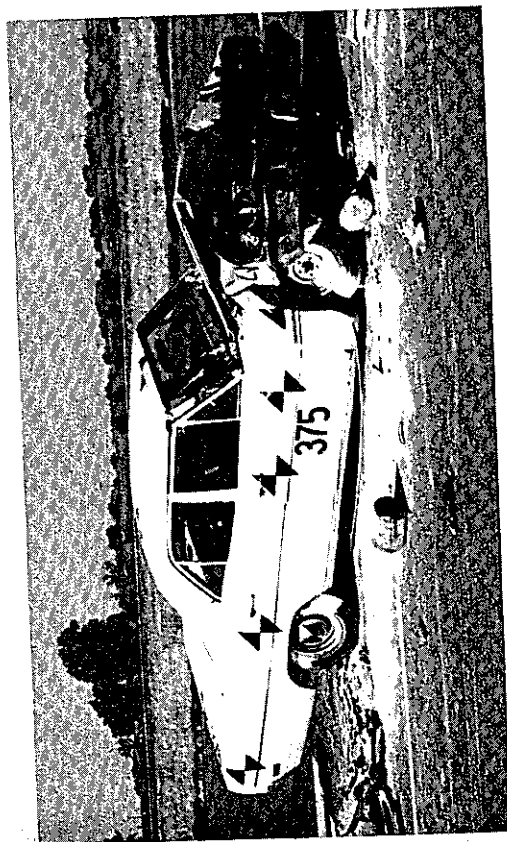
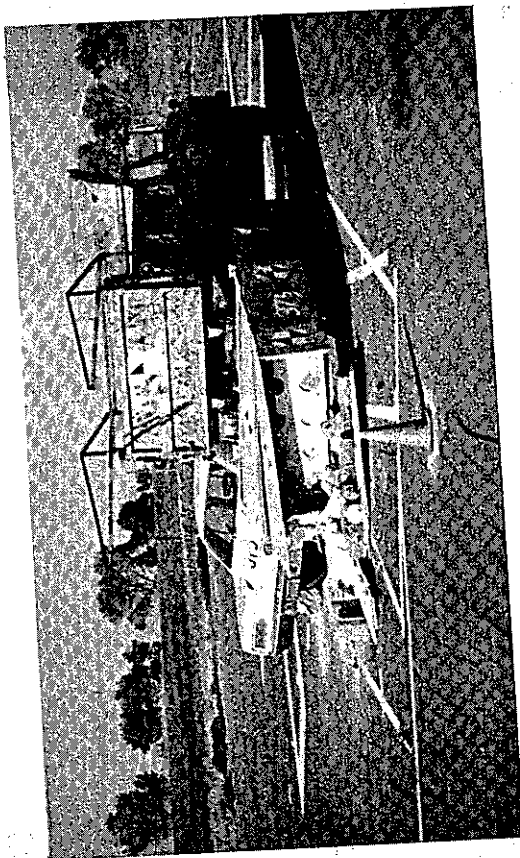
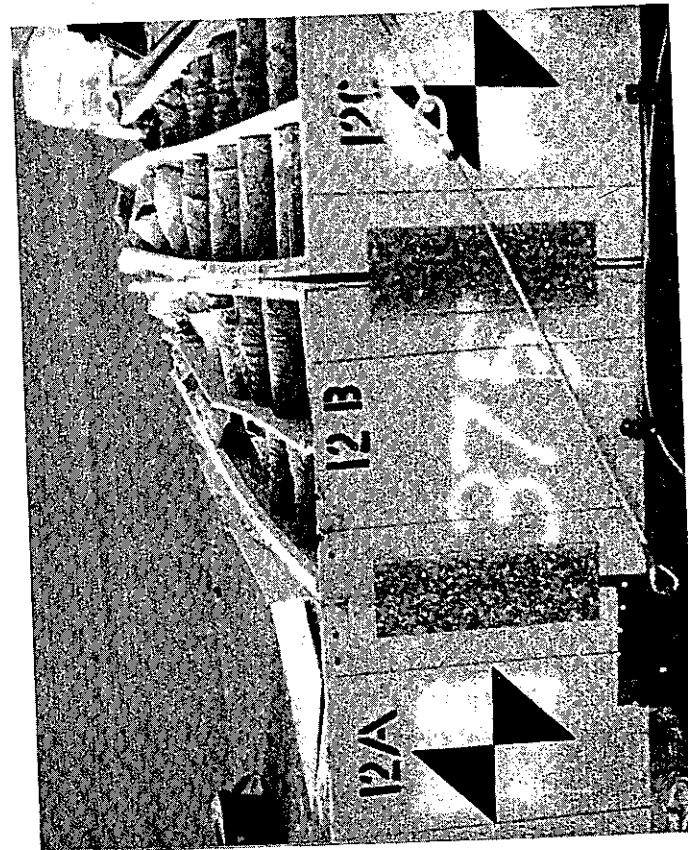
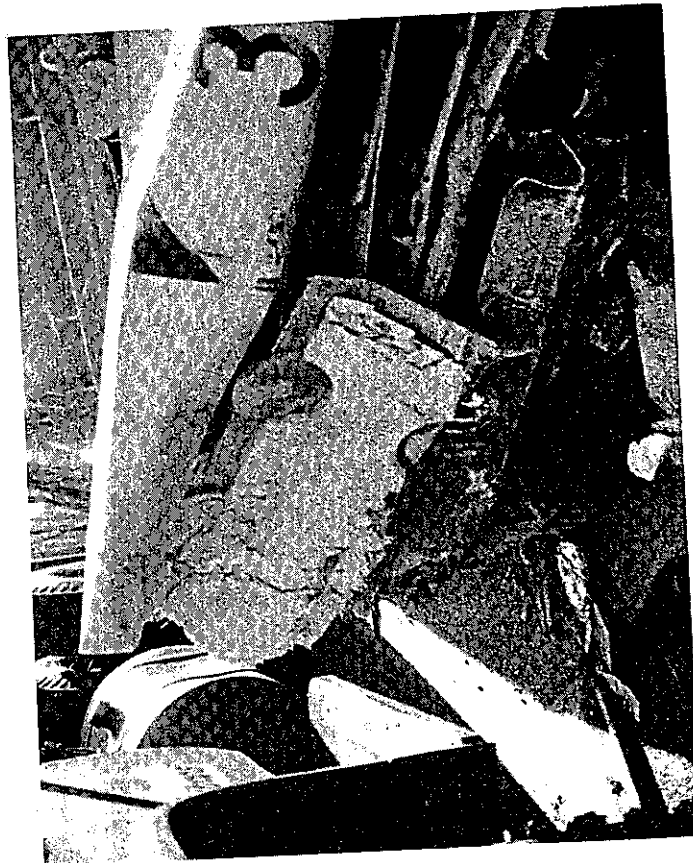
Figure 22. Test 375. Test vehicles and TMA after impact. Lower left: View of crushed cells with plywood cover removed from TMA. Upper and lower right: Final location of car after impact.

frame of the windshield and were forced off to the right side of the car. The car windshield was broken, and the right front corner of the car roof buckled slightly.

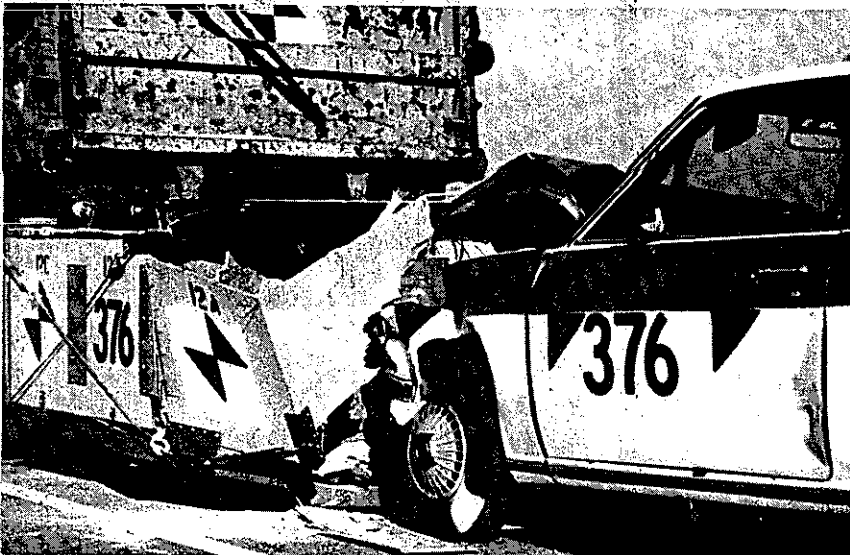
Car wheels did not rise
above steel grid support
on bottom of TMA.

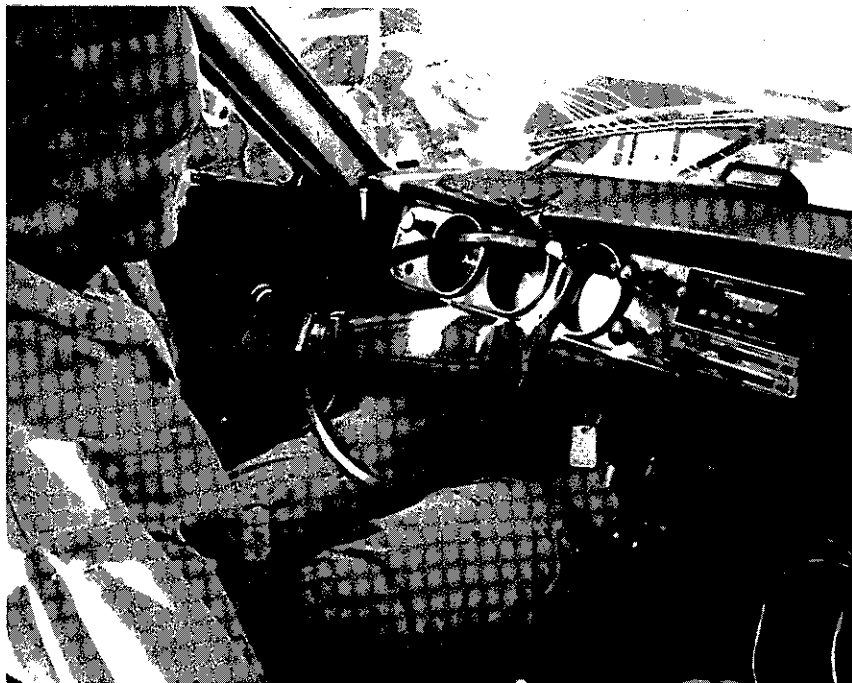
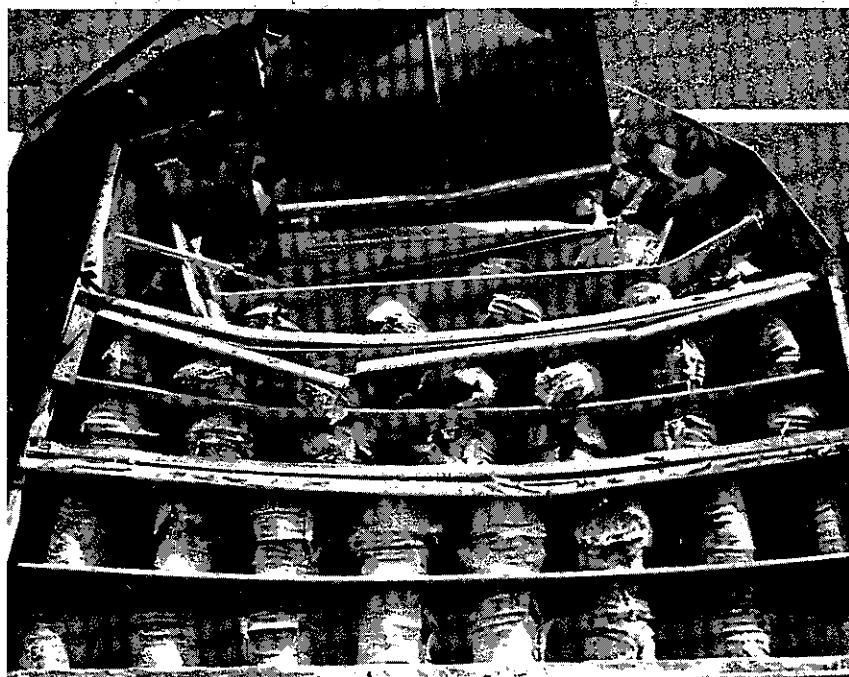
Figure 26. Test 376, Post-Impact.

Upper: Damage to winshield, dash, & steering wheel.
